TEST REPORT

No. : QDIN1911006326SC

Sample Name : GIQIU PVC FLOORING
Product Specification : 2.0mm*2m*20m
Manufacturer : LINYI LINSU ENVIRONMENTAL PROTECTION MATERIAL CO.,LTD
Material and Mark : PVC

Test Item: Chemical Resistance

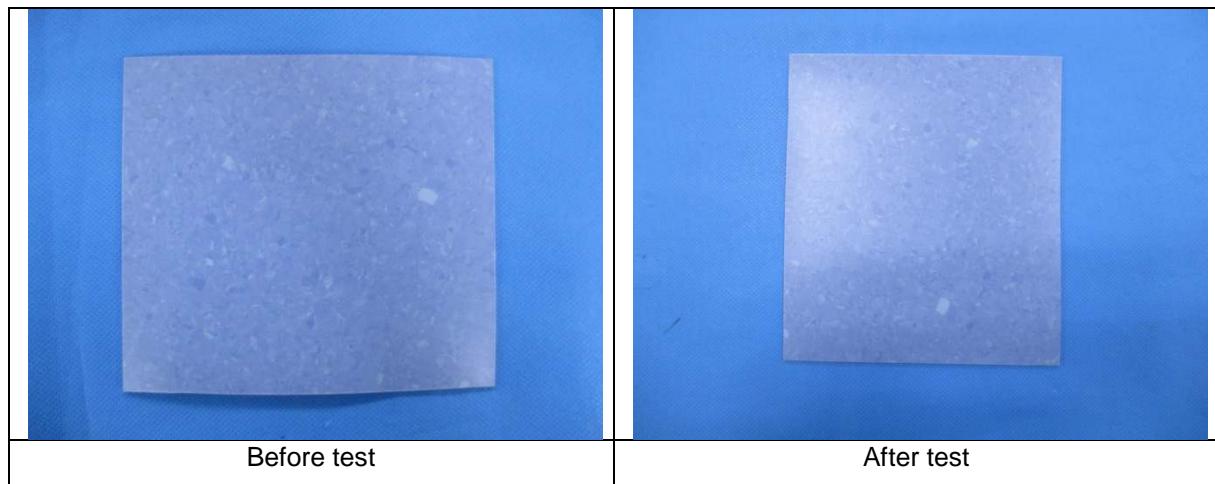
Test Photo:

Test method: drip method

Test reagent: Iodophor (effective iodine content: 4.5g/L ~ 5.5g/L)

Test period: 20min

Test Item	Test Result	Client's Requirement	Conclusion
Chemical Resistance	No residue, no infiltration	No residue or no infiltration	Pass

No.	Test Item	Test Method	Result	Conclusion
1	Chemical Resistance	Provided by client	No residue,no infiltration	Pass
